The Impact of the GPS UTC Anomaly Event of 26 January 2016 on the Global Timing Community

Prof Charles Curry, BEng, CEng, FIET, FRIN *Chronos Technology Ltd*

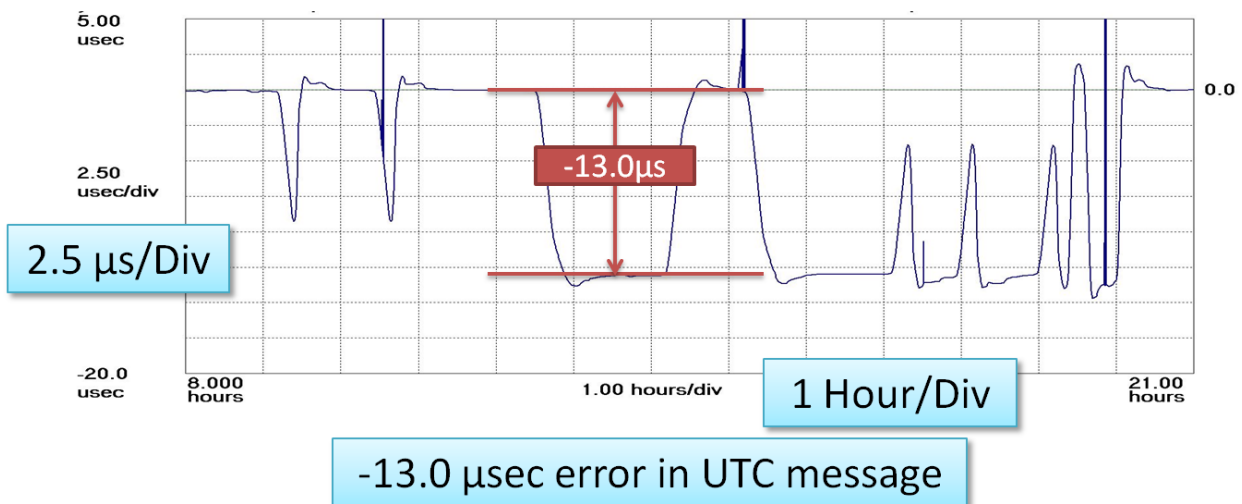
Figure 1: Trace showing full 13 μ sec impact of Anomaly Event on one GPS Timing Receiver

Zero values had been uploaded into t_{ot} and WN_t. This resulted in -13.7 μsec for A₀ and -13 μsec for Δt_{UTC} the offset experienced by some receivers.

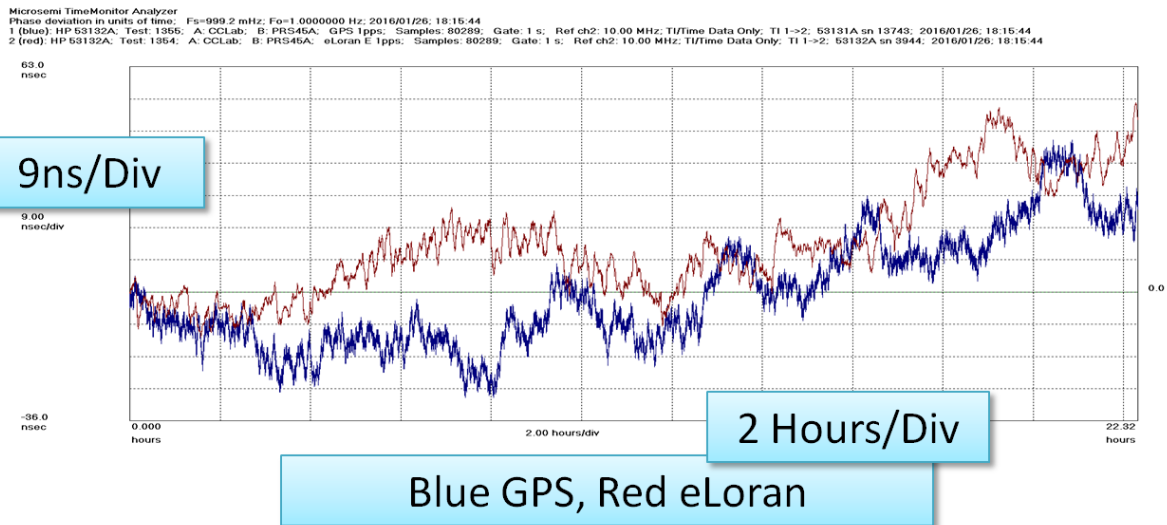
Figure 3: GPS Receiver not impacted

Some conclusions from this include mitigation due to RAIM effects. Some receivers were not impacted because they did not need new ephemeris during the event or as only fifteen satellites were impacted they collected ephemeris from a 'good'
