# The Impact of the GPS UTC Anomaly Event of 26 January 2016 on the Global Timing Community

Prof Charles Curry, BEng, CEng, FIET, FRIN *Chronos Technology Ltd*

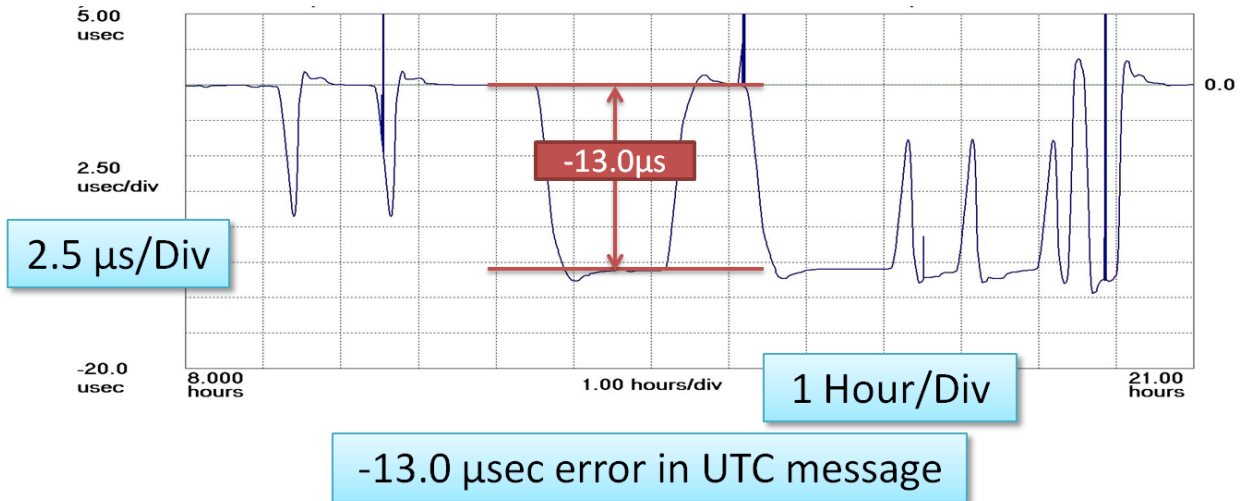
Figure 1: Trace showing full 13 µsec impact of Anomaly Event on one GPS Timing Receiver

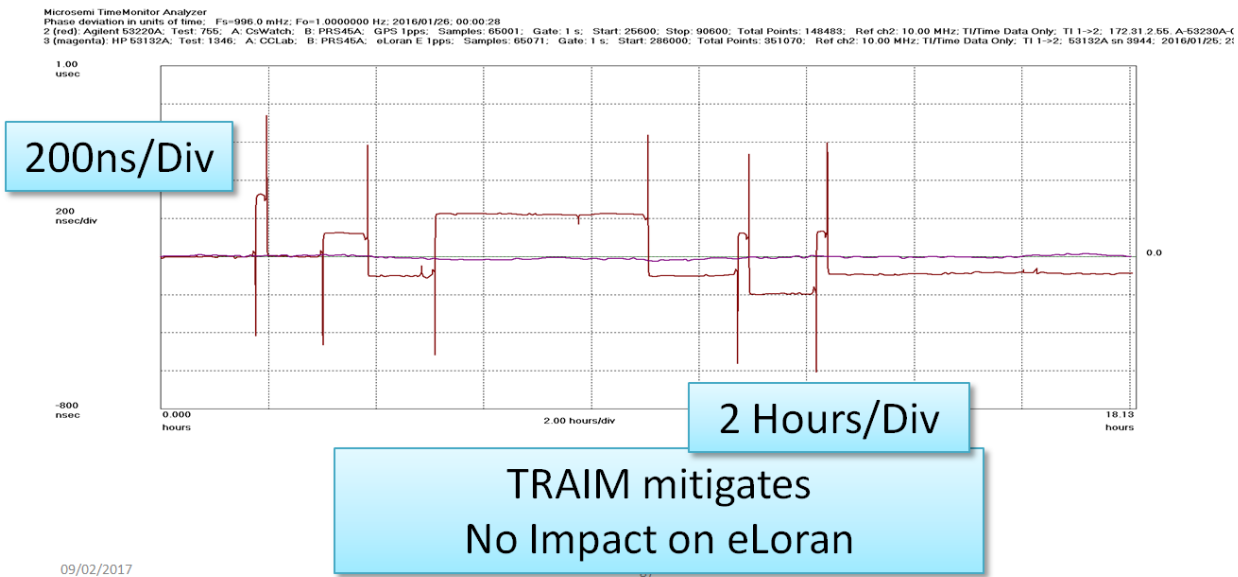
Figure 2: TRAIM Mitigates impact. No Impact on eLoran

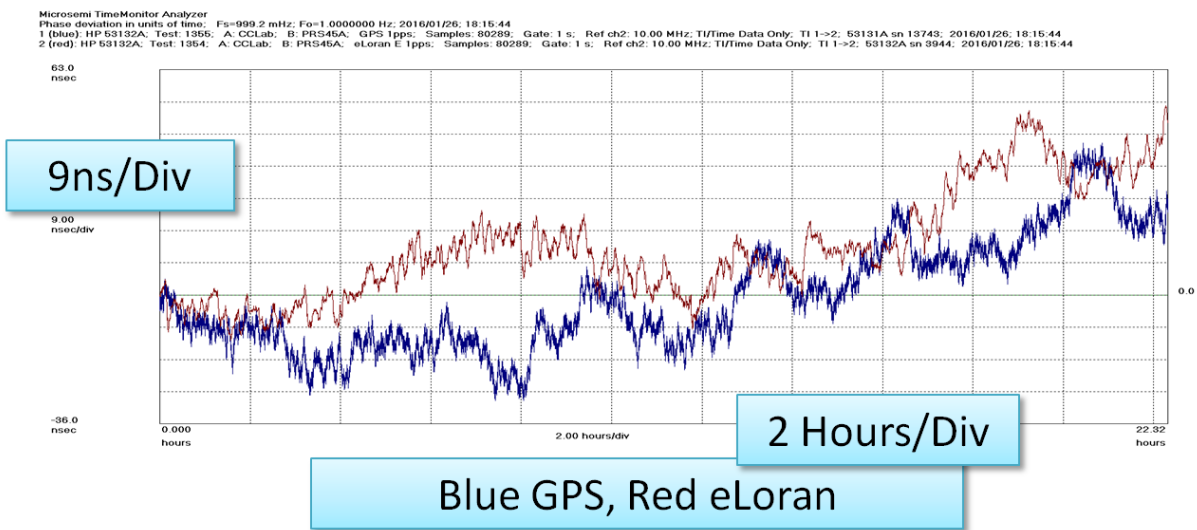
Figure 3: GPS Receiver not impacted
