3G Mobile Network Sync Failure in Backhaul

Introduction

CASE STUDY

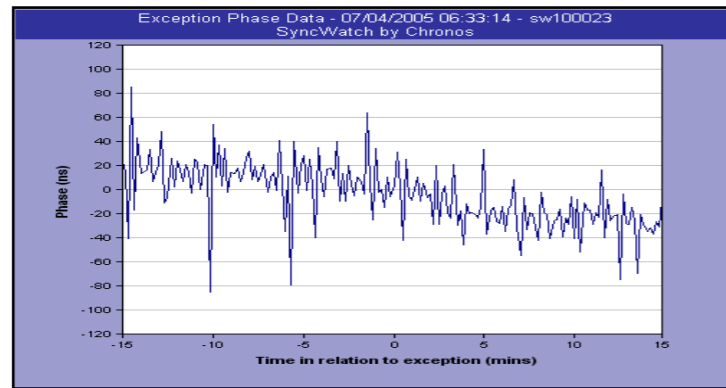
MTIE of HDSL Delivery when working incorrectly

MTIE plots are shown for a number of 15 minute samples which all had problems breaking the specification for HDSL delivery. Looking at the phase plots the start of the problem coincided with a very large phase jump followed by a gradually increasing slope indicating a frequency drift.

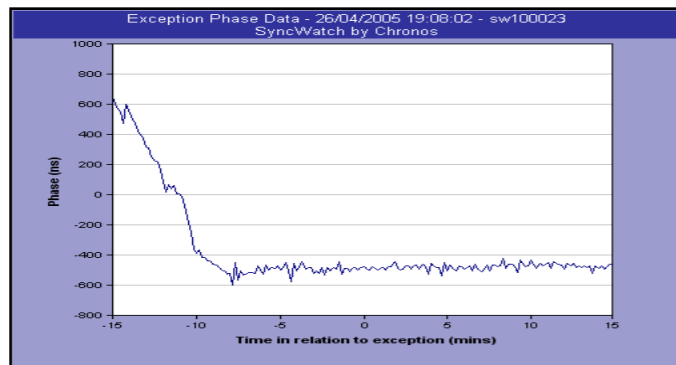
Phase Plot at end of Frequency Offset showing return to normal operation

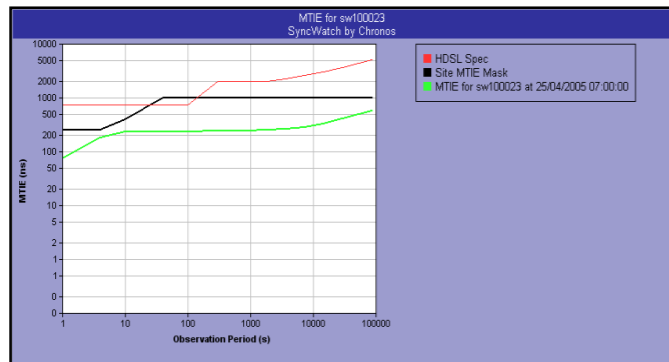
MTIE showing sync performance back to normal after fault condition

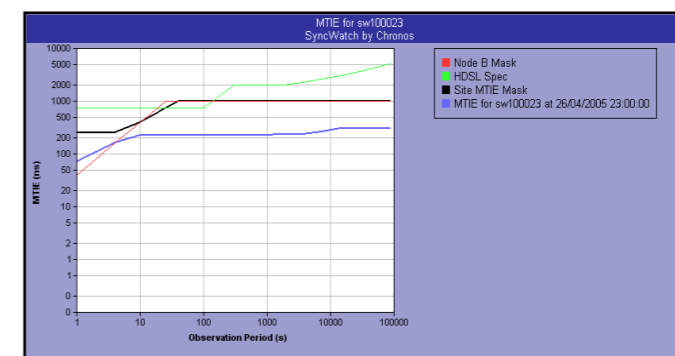
The green line corresponds to the measured performance, the red line to the ETSI specification for an HDSL line, the black line represents the mask set on the SyncWatch Probe. An alarm will be generated if this mask is exceeded in SMS text message to the support team mobile phone.
