# Detecting and Geolocating the source of GPS Interference

## Issues with Repeating Antenna

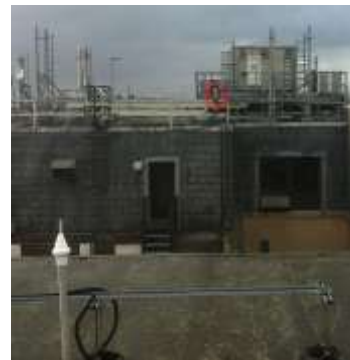
Repeating antenna is circled in red with GPS antenna in foreground

Chronos re-visited the site with handheld GPS interference detectors, CTL3500 and CTL3520, to determine the source of interference. Within a few minutes the source was discovered and located using the CTL3520 handheld with GPS direction finding capability. Once the offending antenna was detached, all the affected GPS systems reported stronger signals and began to lock.

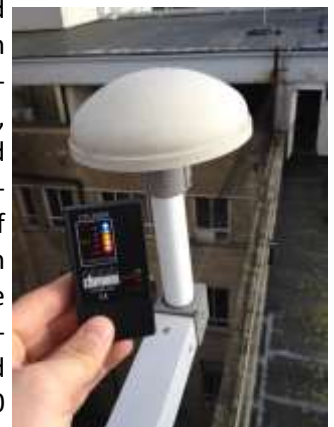
CTL3500 handheld GPS jamming detector
