# Major Telecom Operator's Timing Disrupted

## *GPS Jammer employed to defeat a Fleet Tracking System*

CASE STUDY

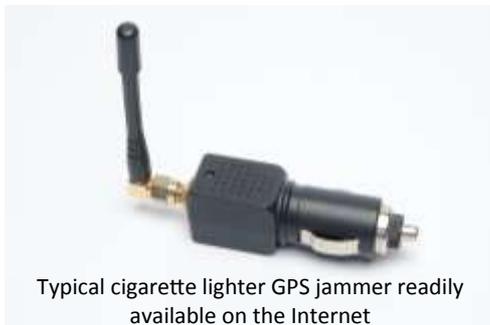
Typical cigarette lighter GPS jammer readily available on the Internet

After explaining the situation to the plant equipment company's fleet manager, and demonstrating the CTL3510 and CTL3520, the fleet manager was able to recover two jamming devices from company vehicles. It was suspected that up to three more jammers may also have been in use by other drivers based on the results from the tracking system.

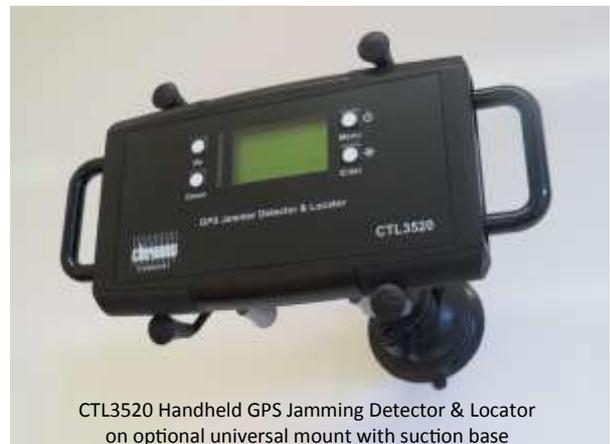
CTL3520 Handheld GPS Jamming Detector & Locator on optional universal mount with suction base

The next course of action was to issue a local engineer with handheld detectors—the CTL3510 Jamming Detector and the CTL3520 GPS Jamming Detector and Locator, and attempt to capture and locate the interference source.

were later downloaded and matched to the outage times seen by the SSU. The CTL3520 was then used to locate the source of the interference.

Using the CTL3520, the engineer was able to locate jamming signals coming from two vehicles both parked in the grounds of the plant equipment company.

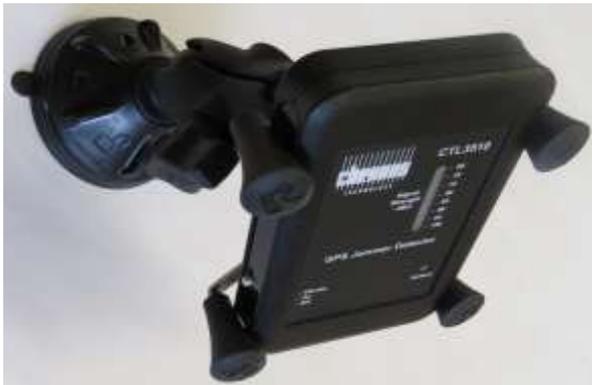
CTL3510 on optional universal mount with suction base

The sporadic nature of the events meant that a little luck would be needed for the engineer to be onsite at the time of an event. However, on the second and third site visits, the engineer was able to capture two jamming events in action. The CTL3510 was initially used to detect the presence of an interfering signal, the results of which
